Imagery Shows Sanitization Effort at the Attacked Mojdeh Site a.k.a. the “Lavisan 2” Campus

By David Albright, Sarah Burkhard, Spencer Faragasso, and the Good ISIS Team

August 27, 2025

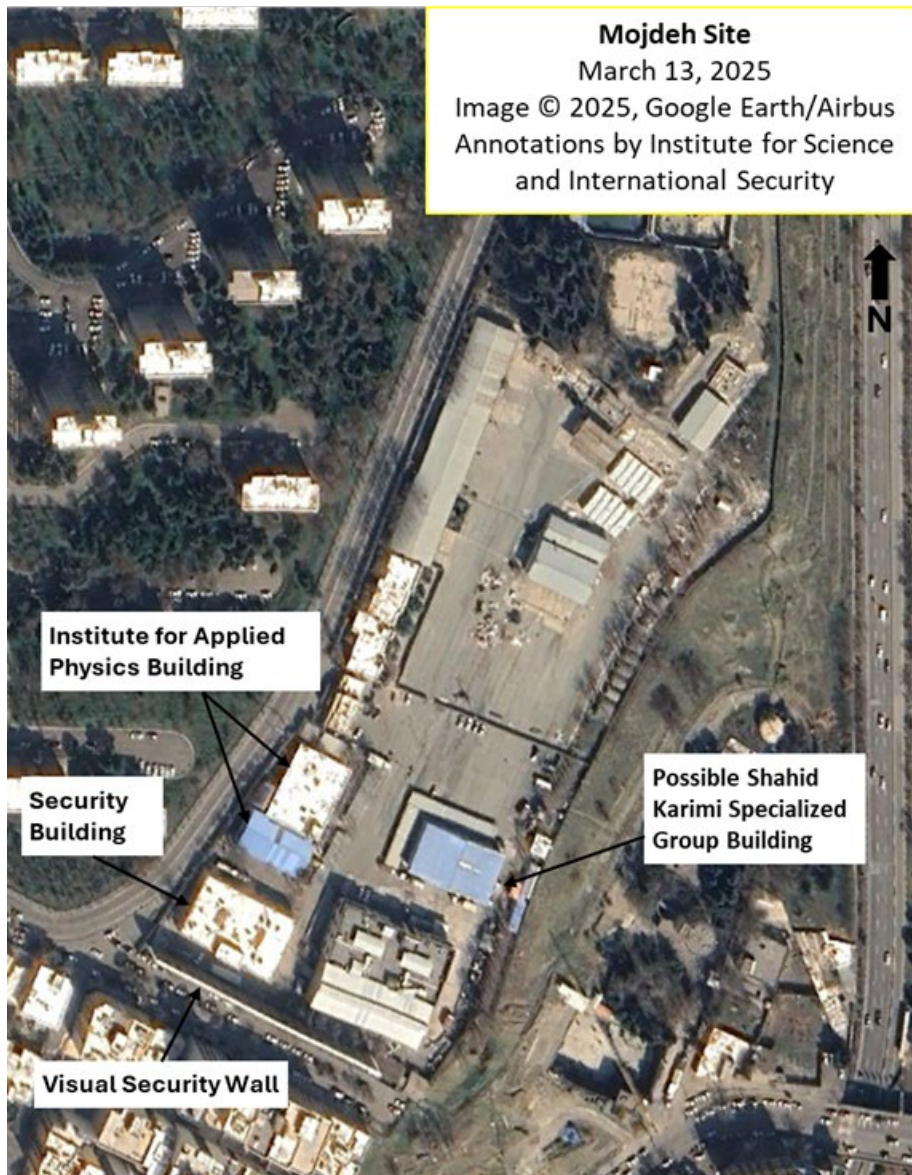
Figure 1. A Google Earth image of the Mojdeh Site taken on March 13, 2025, several months before the attack by Israel.

The Mojdeh site is next to Malek Ashtar University and was the headquarters of the follow-on organization to the Amad Plan, which had been shut down in 2003. The successor organization, known initially by its acronym, SADAT, was a smaller, more camouflaged nuclear weapons program. This organization evolved, eventually being subsumed in about 2011 by the SPND, which took over the campus as its initial headquarters. This campus was also the location of the Modern Defense Readiness Test Center, the Institute of Applied Physics, and later SPND’s Shahid Karimi Group. Shahid Karimi Group was identified by the U.S. Treasury as an entity working on missiles and explosives projects connected to SPND. Figure 1 shows a Google Earth image of the site taken several months before the attack by Israel.

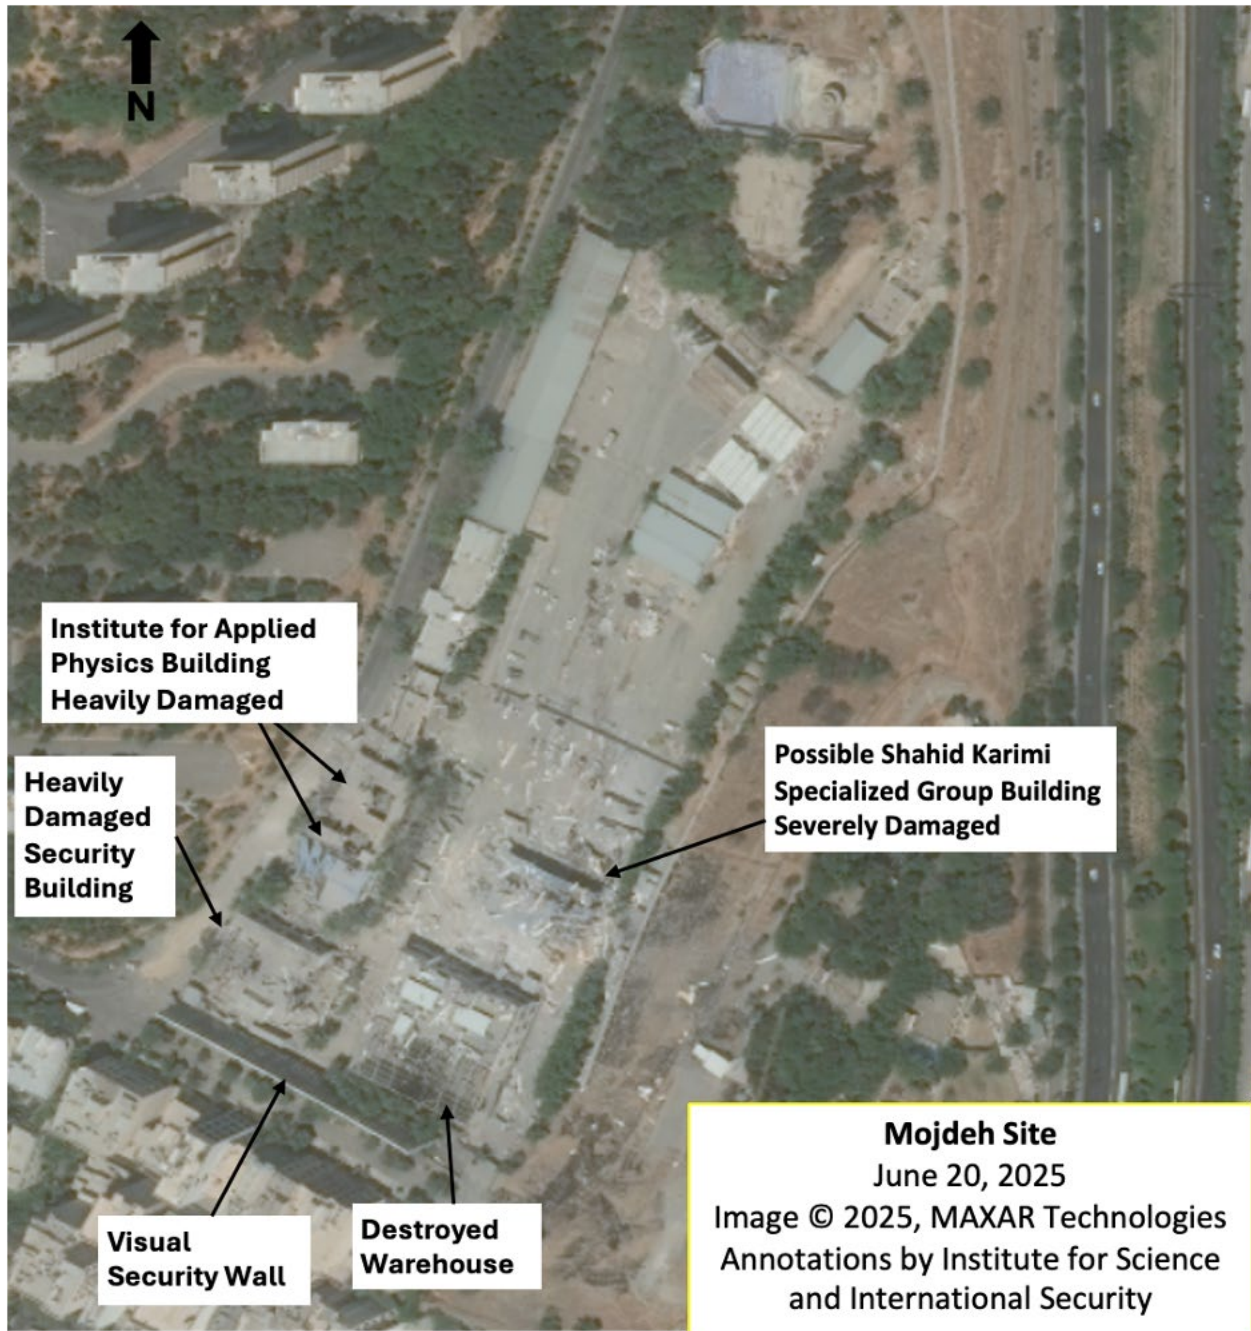
Figure 2. A June 20, 2025, MAXAR Technologies image of the Mojdeh site.

Physics according to various open sources. The second round of airstrikes destroyed the Institute for Applied Physics building, caused additional damage to a nearby security building, and destroyed an onsite warehouse/workshop. The fact that Israel chose to strike this site twice demonstrates its importance.

A June 20, 2025, image shows the aftermath of the second strike. Several buildings can be seen either completely destroyed or highly damaged from the attack, with debris strewn across the complex (see Figure 2). An image from July 3, 2025, shows the beginning of cleanup operations. Debris is starting to be cleaned up and removed from the site (see Figure 3). In this image, the remains of the highly damaged or destroyed buildings are still present. By August 19, 2025, the Institute for Applied Physics building and its attached workshop have been completely razed and cleared (see Figure 4). The building suspected to house Shahid Karimi Specialized Group had also been razed and cleared. Clearing efforts had not yet commenced at the damaged security building or the destroyed warehouse/workshop.

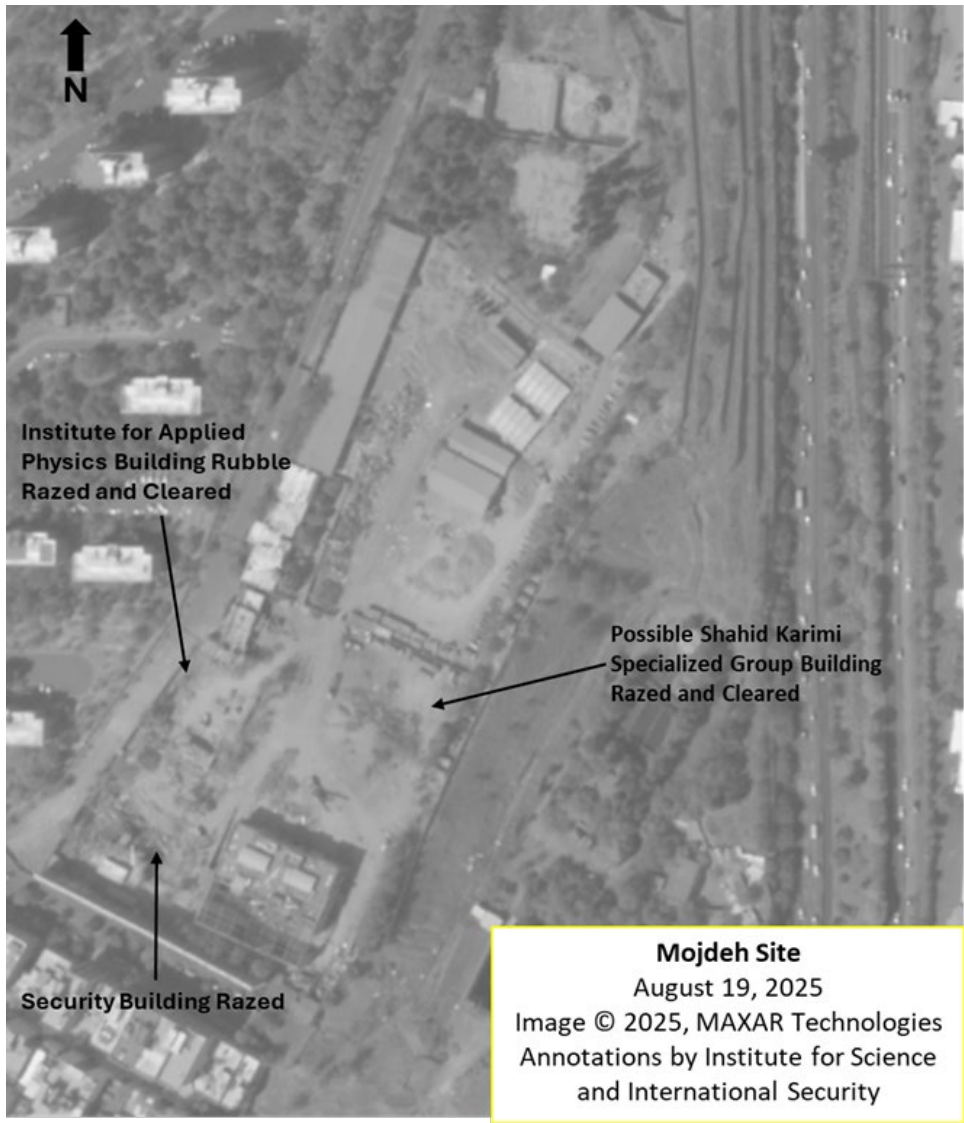
Figure 4. An August 19, 2025, MAXAR Technologies image of the Mojdeh site. Several buildings have been razed and cleared.

High-resolution MAXAR Technologies satellite imagery taken on July 3 and August 19, 2025, of the Mojdeh (also known as Lavisan 2) site obtained by the Institute shows a significant effort by Iran to rapidly demolish damaged or destroyed buildings, likely to sanitize any incriminating nuclear weapons research and development activities. The IAEA established a direct connection between Iran’s Amad Plan and the Mojdeh site but was never able to visit the site or interview key associated personnel.

The rapid work by Iran to quickly demolish and clear the rubble of these important buildings appears to be an effort to sanitize the site and limit the availability of any possible future inspection from obtaining evidence of undeclared nuclear and nuclear weapons related research and development activities that may have occurred there. Iran has previously sanitized sites to stonewall IAEA inspectors and hide its past nuclear weapons development work.
